In data de 02.07.2018 stia mobila nr1 a fost amplasata in zona de nord a platformei industriale de est conform planului de monitorizare suplimentara al APM Prahova. Mai jos sunt prezentate rezultatele monitorizarii in perioada 30.07.2018-05.08.2018 precum si harta pozitionarii acestuia.

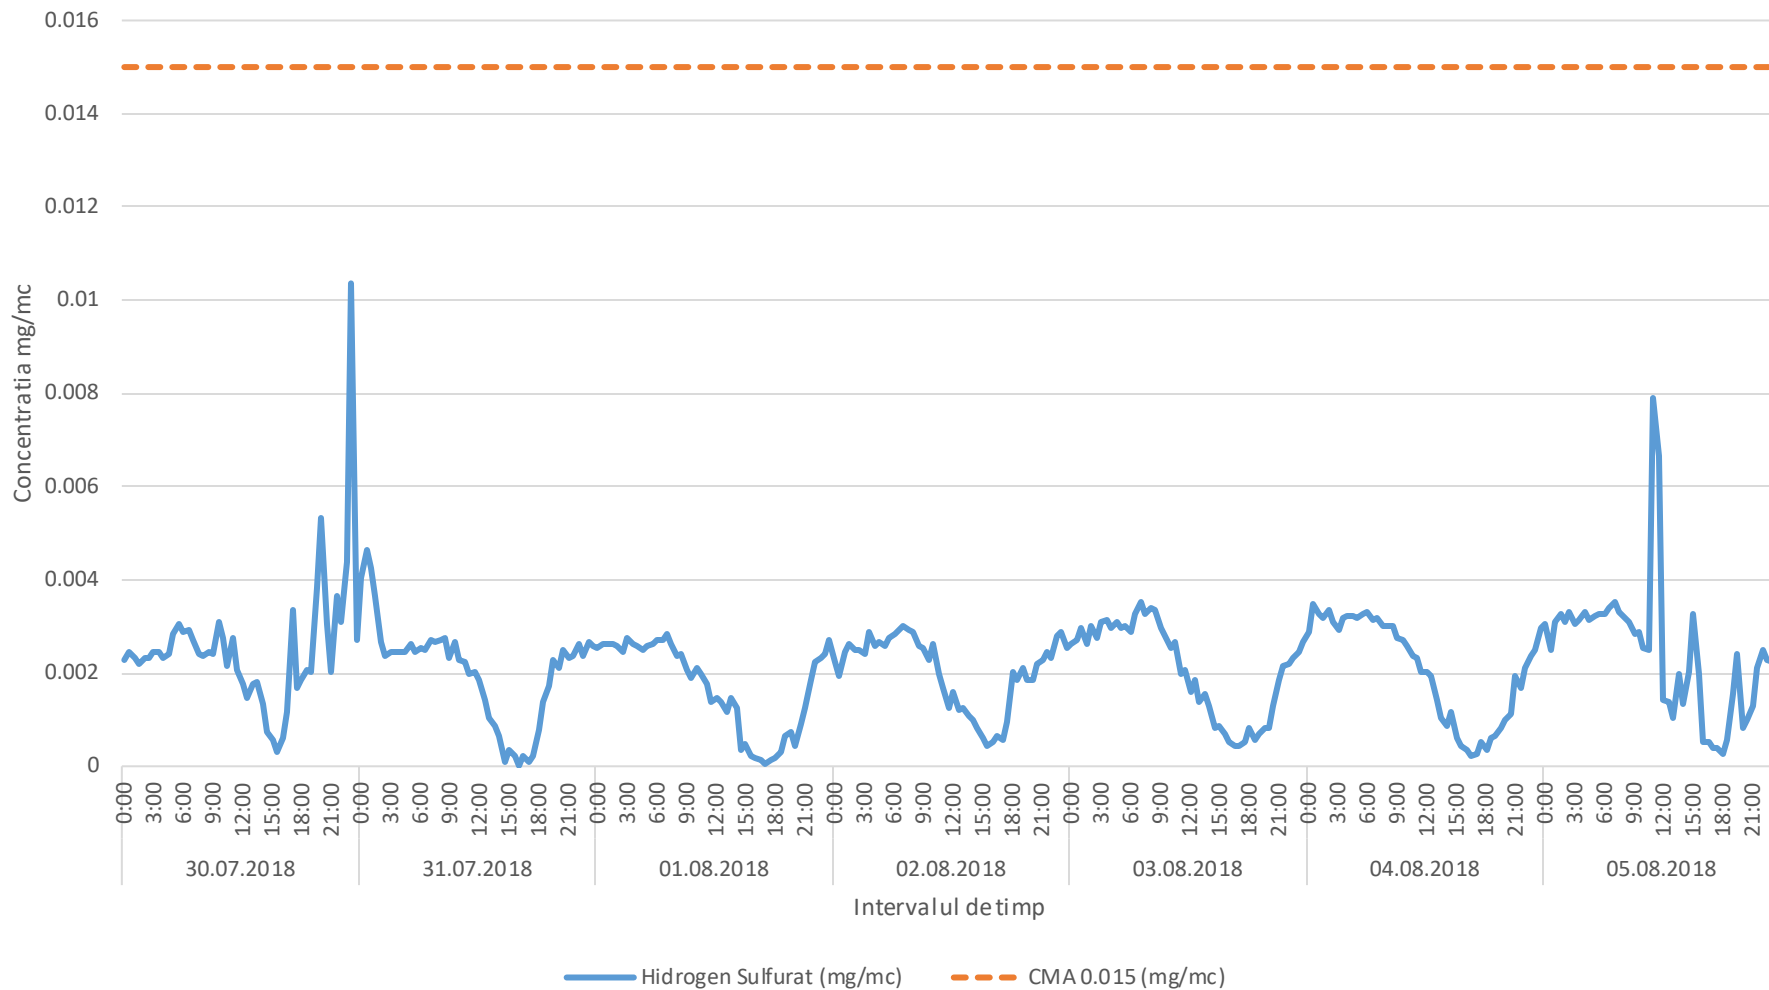
Variatia indicatorului H2S in intervalul 30.07.2018-05.08.2018 in zona de nord a platformei industriale Lukoil

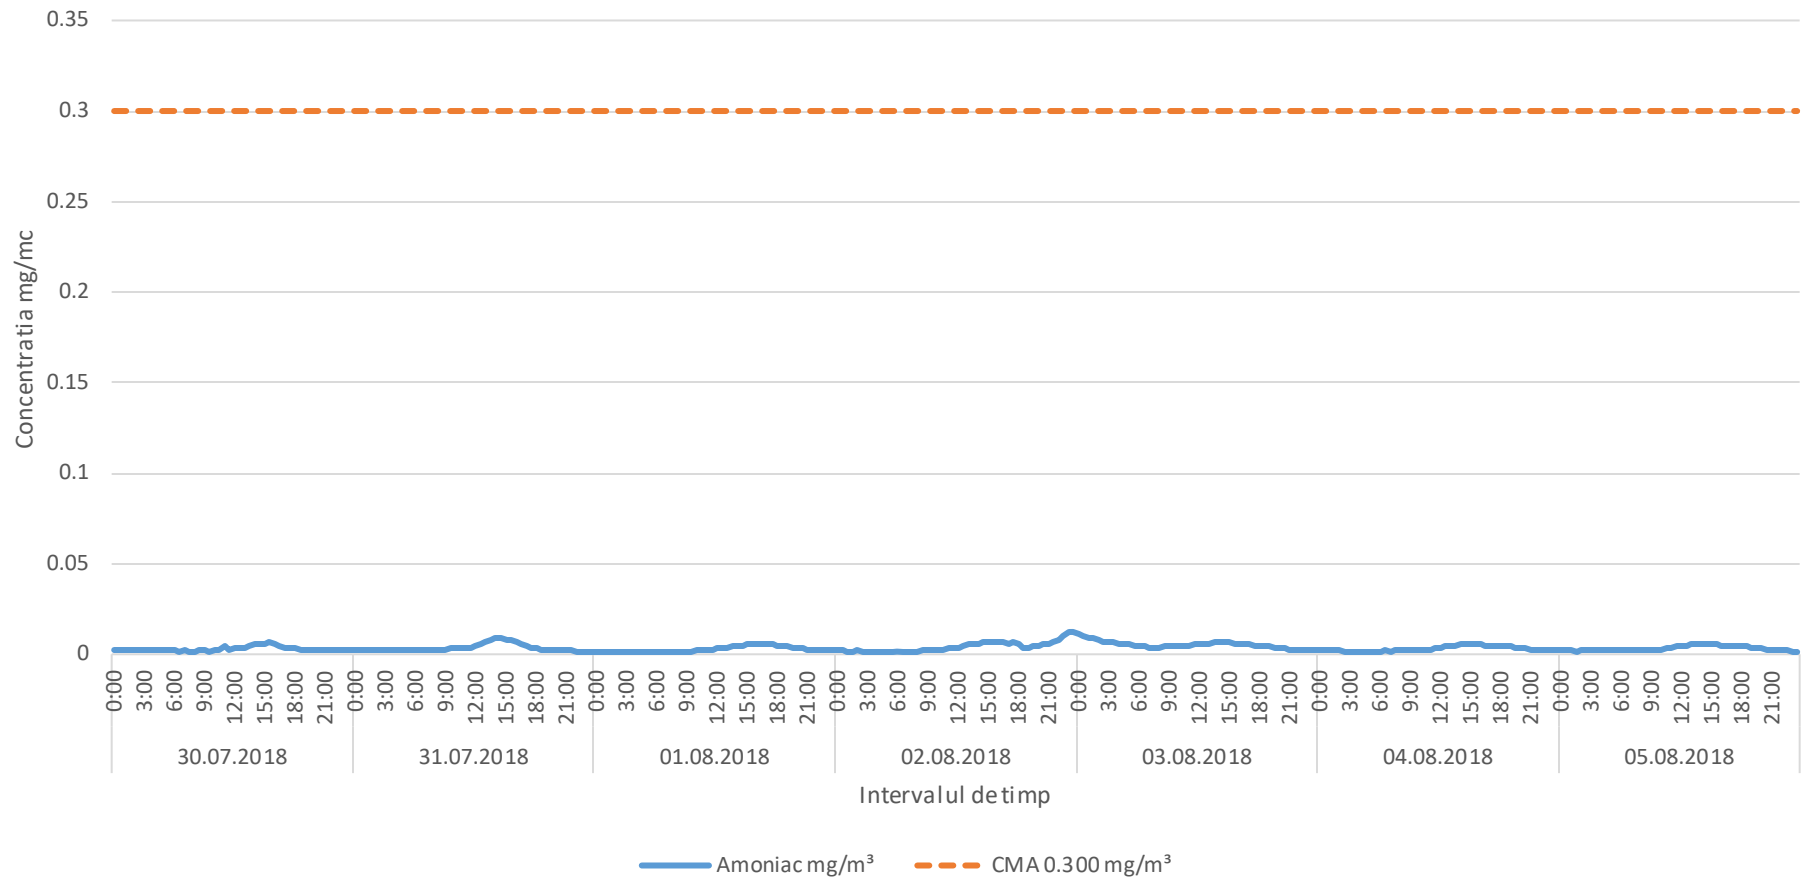
Variatia indicatorului NH3 in intervalul 30.07.2018-05.08.2018 in zona de nord a platformei industriale Lukoil

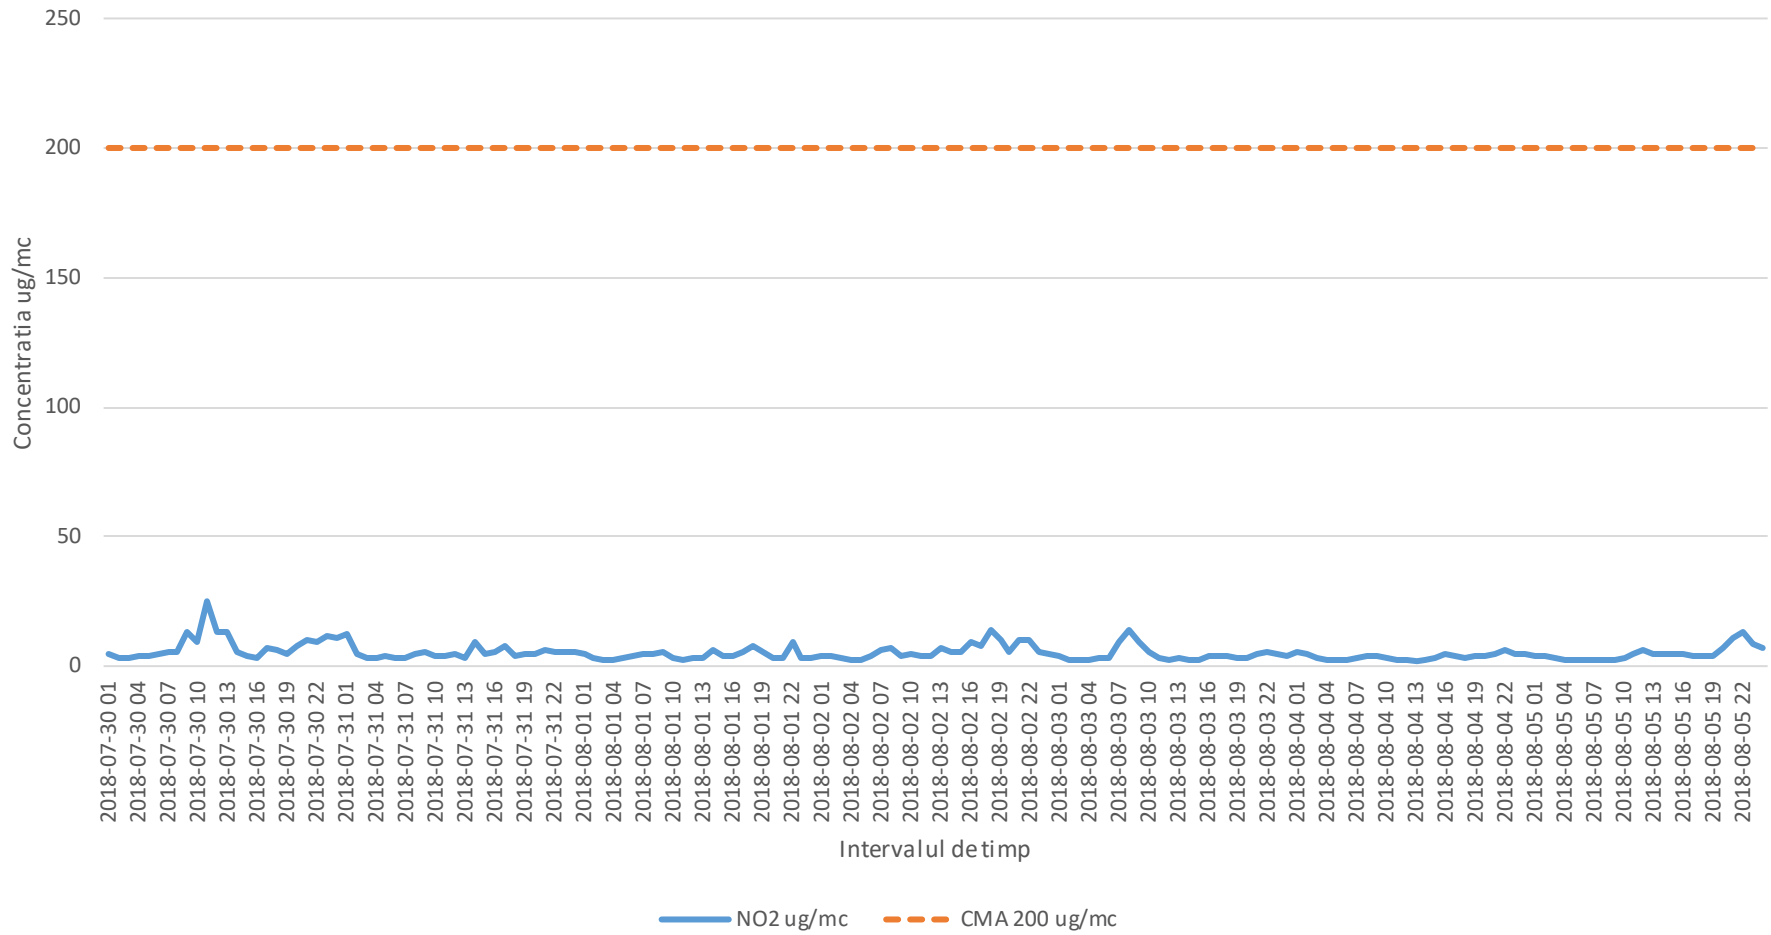
Variatia indicatorului NO2 in intervalul 30.07.2018-05.08.2018 in zona de nord a platformei industriale Lukoil
